# Manhole Inspection Summary

Manhole # S45A\_\_022MH

Insp Date: **6/27/08 1:33 PM**

**Location** Address: **Orleans**

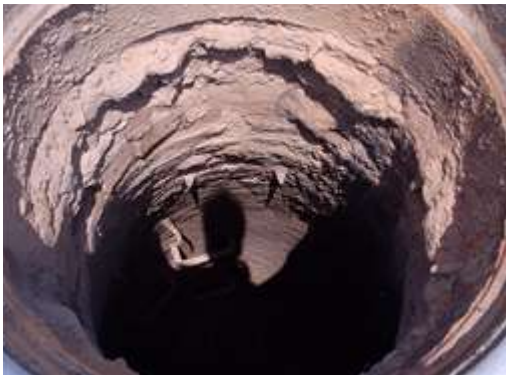
Defect 2

Infiltration: ☐ None ☐ Joint ☐ Cracks ☒ **Mortar** ☐ Roots ☐ Wall

Infiltration: ☐ None ☐ Joint ☐ Cracks ☐ Mortar ☐ Roots ☒ **Wall**

Infiltration

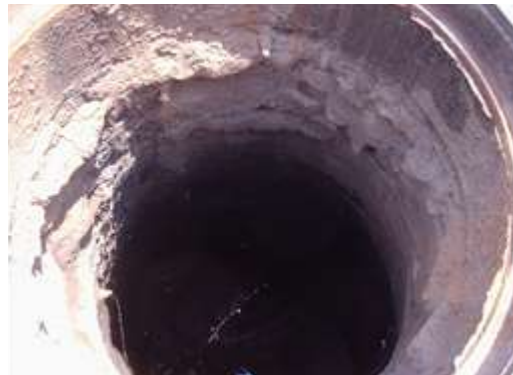
Defect 1

☒ **Leaks**

Frame Leaks

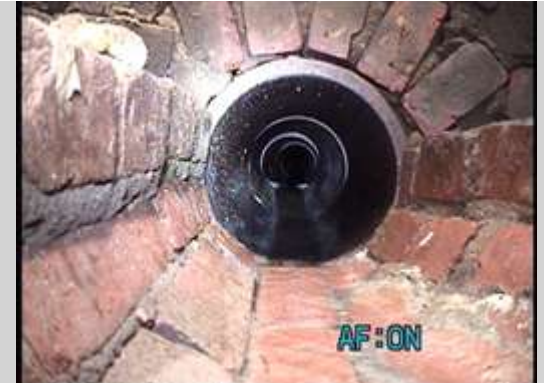
12 O'Clock Outflow

8 in. Circular Gravity Sewer  
Pipe Out @ 12 O'Clock

Pipe Height: **8.4** (in.) Rod and Bar (Angled)  
Pipe Material: **Clay** ☐ Pipe Lined  
Invert Depth: **11.35** (ft.) Flow Characteristics: **Slow**  
Deposits: ☒ None ☐ Mud ☐ Sludge ☐ Debris ☐ Grease  
Silt Depth: (in.) Deposits Extent:  
Infiltration: **None** Pipe Seal Cond: **Sound**

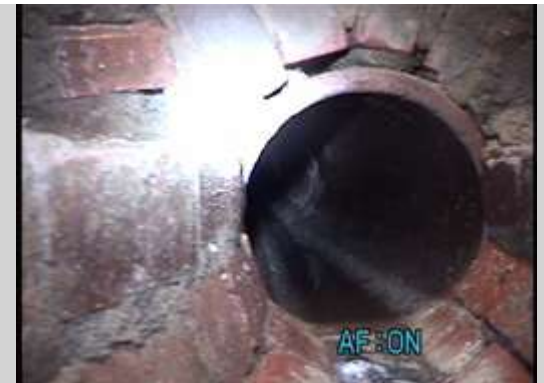
3 O'Clock Inflow

8 in. Circular Gravity Sewer  
Pipe In @ 3 O'Clock

Pipe Height: **8.4** (in.) Rod and Bar (Angled)  
Pipe Material: **Clay** ☐ Pipe Lined  
Invert Depth: **11.30** (ft.) Flow Characteristics: **Slow**  
Deposits: ☒ None ☐ Mud ☐ Sludge ☐ Debris ☐ Grease  
Silt Depth: (in.) Deposits Extent:  
Infiltration: **None** Pipe Seal Cond: **Sound**

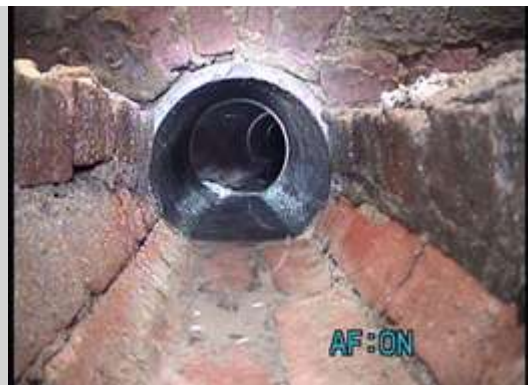
6 O'Clock Inflow

8 in. Circular Gravity Sewer  
Pipe In @ 6 O'Clock

Pipe Height: **8.4** (in.) Rod and Bar (Angled)

Invert Depth: **11.25** (ft.) Flow Characteristics: **Slow**

Infiltration: **None** Pipe Seal Cond: **Sound**
